# ADA Bin Door Jamming Trouble Shooting Guide

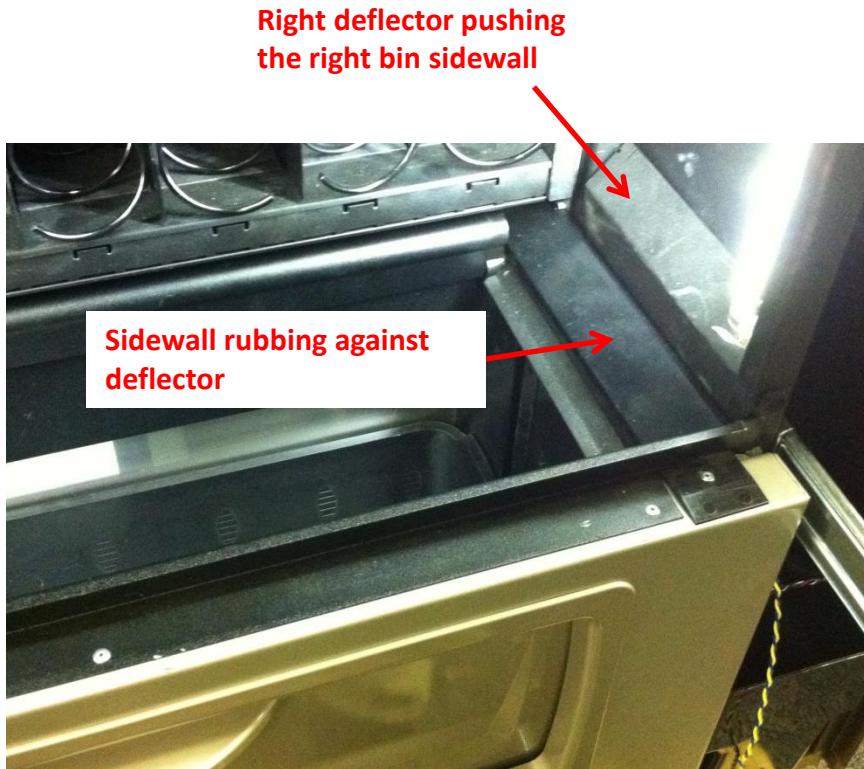
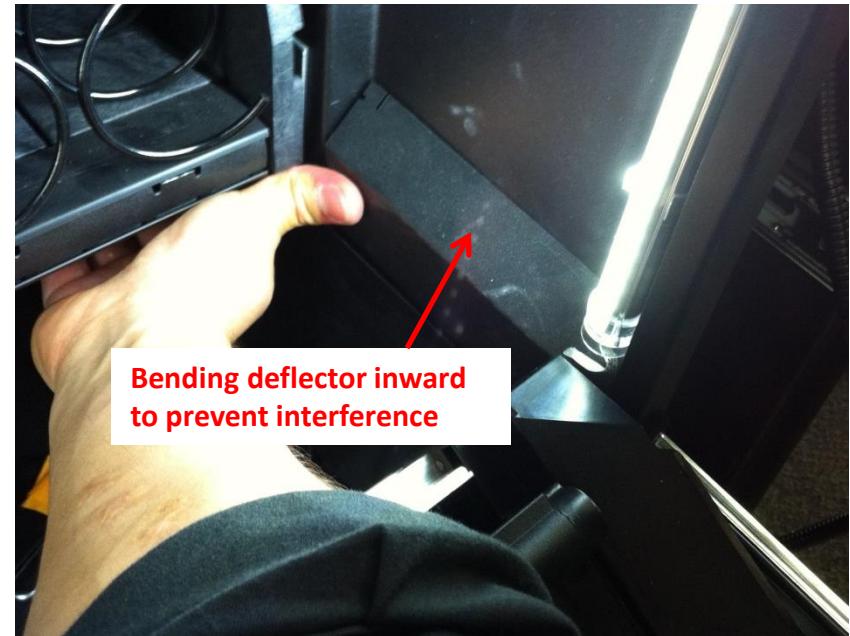
## Cabinet interference

Remove the bin from the cabinet by unlatching, rotating out of cabinet and sliding off hinges. With the bin out of the cabinet, test it to see if the door still jams. If it does not, then something in the cabinet is possibly causing bin not to properly function

Check to see if there are any brackets mounted to the cabinet that interfere with the bin, specifically the plastic sidewalls. This can cause the gear track to flex and, consequently, the gear racks to bind on the bucket.

If any interference is found, adjust the cabinet parts to counter the issue (see pic 2). Retest the bin while installed on the cabinet to see if this has fixed the door jamming.

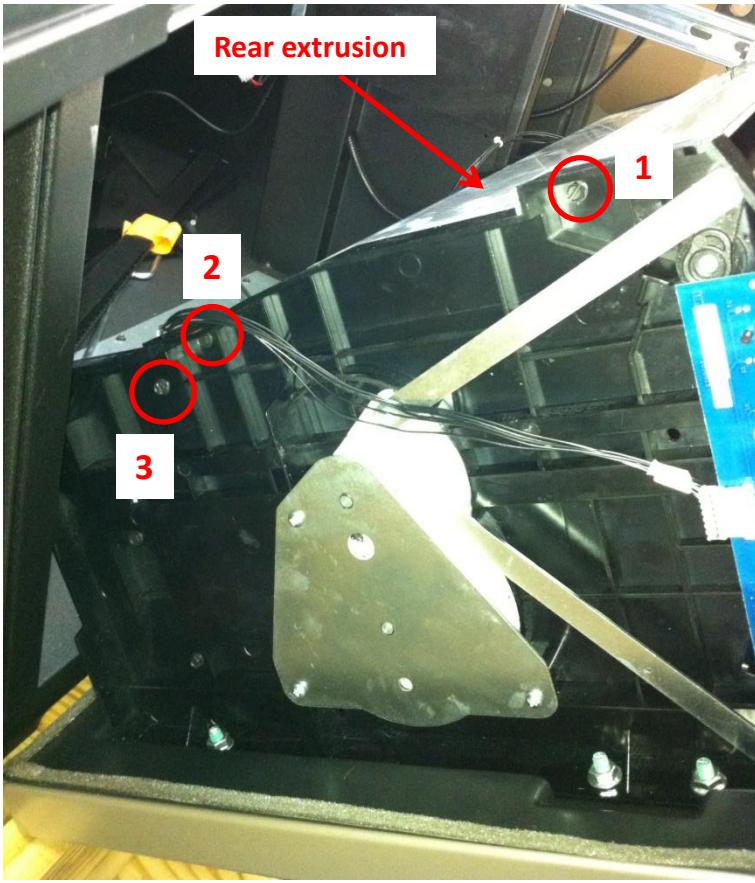
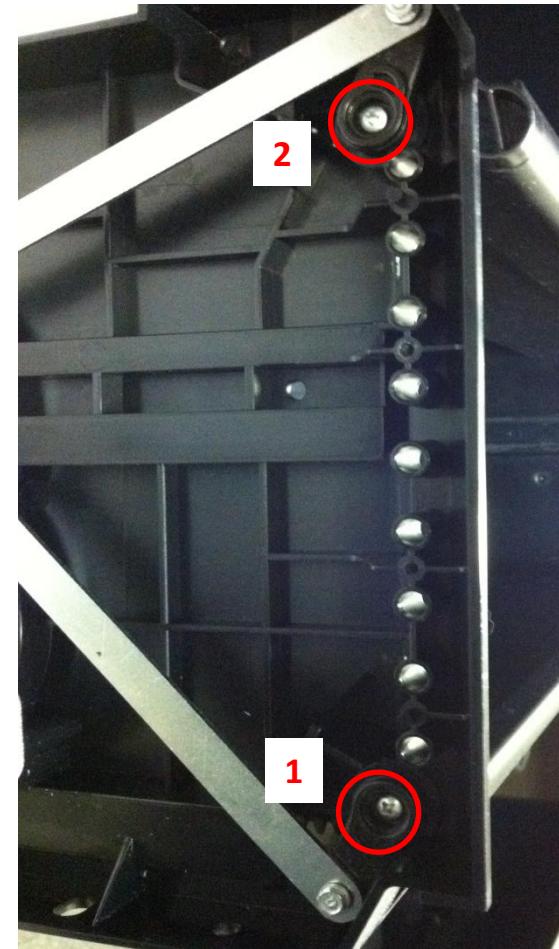
## Extrusion and vandal flap length

The aluminum extrusions may be too small, causing the sidewalls to be non-perpendicular to the gear racks which would lead to binding. In order to counter this, unlatch the bin and rotate out of cabinet. Loosen the  $\frac{1}{4}$ " black hex head screws (less than half a turn) securing the rear extrusion to the bin. Start by loosening the top screw then reinstall bin into cabinet and test door. If the door still jams, repeat the steps above with the second screw then the third screw. (only necessary to try this on one side)  
If loosening the extrusion screw has not fixed door jamming, try loosening the screw on the front vandal flap insert and testing door. Try on the back vandal flap if this does not fix the issue. (only necessary to try this on one side)

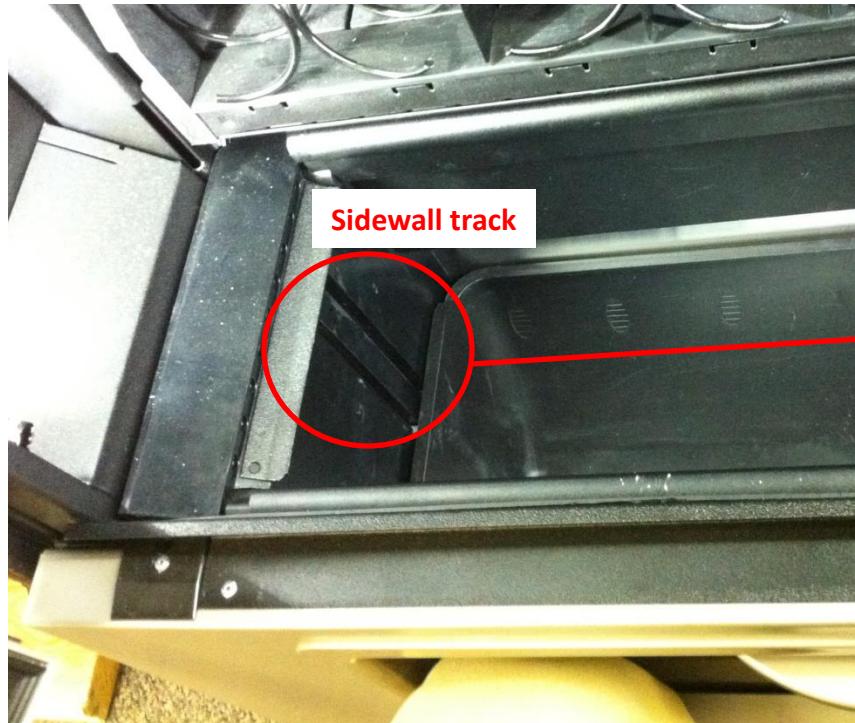
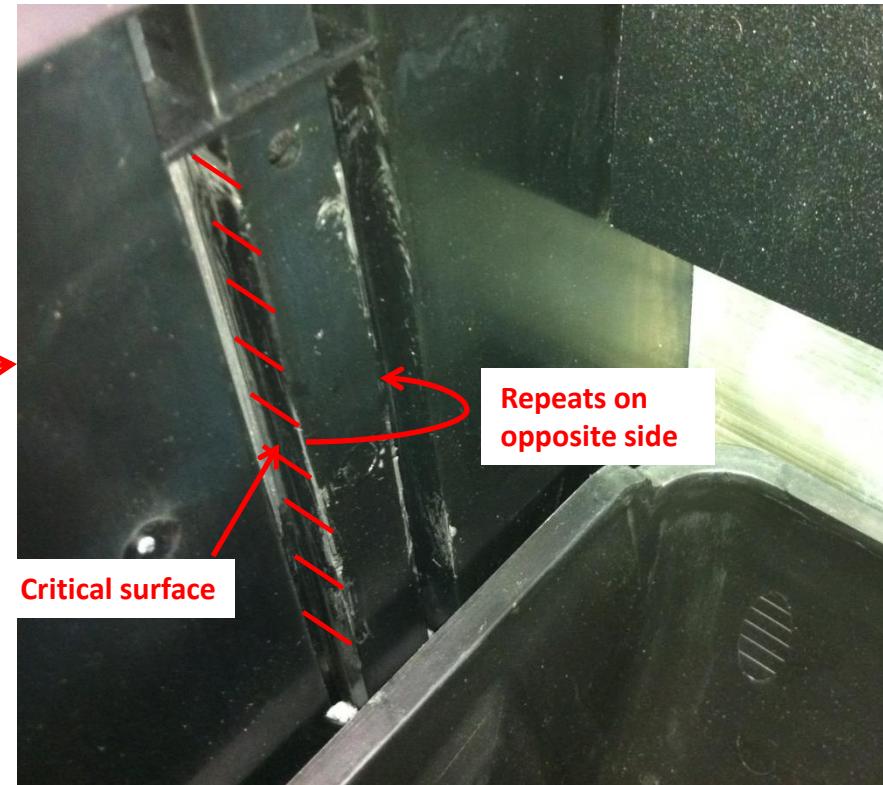
## Add grease to tracks

As the gear racks of the bucket travel up and down the sidewalls, there may be too much friction between both components for the door to close. To counter this issue, try adding grease/lubricant\* to critical surfaces (highlighted above) to ease the sliding. Try not to get any grease anywhere except on the critical surfaces.

**\*Grease/lubricant should be food grade and as dark as possible so not seen through glass door**

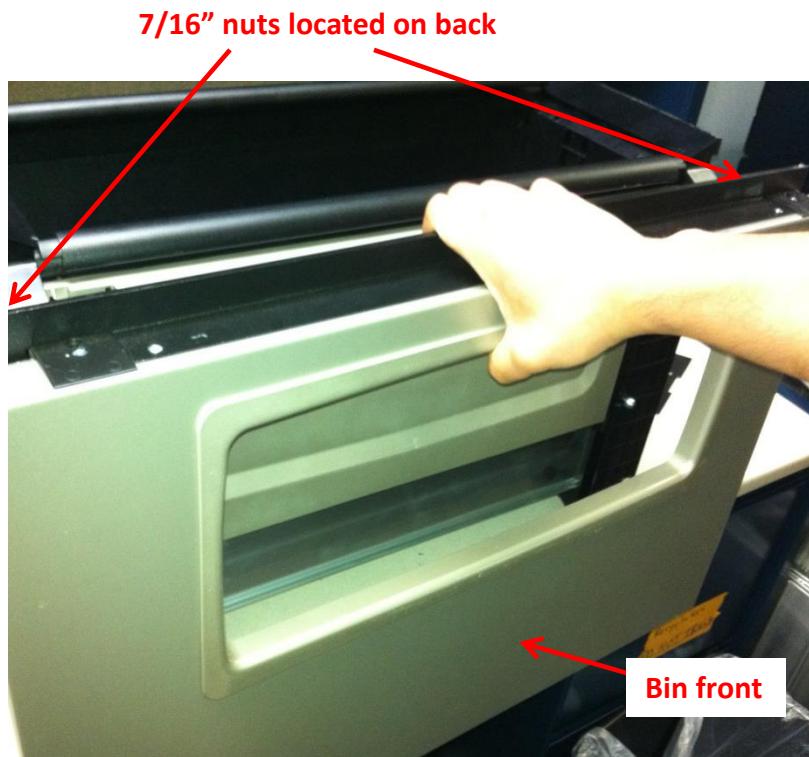
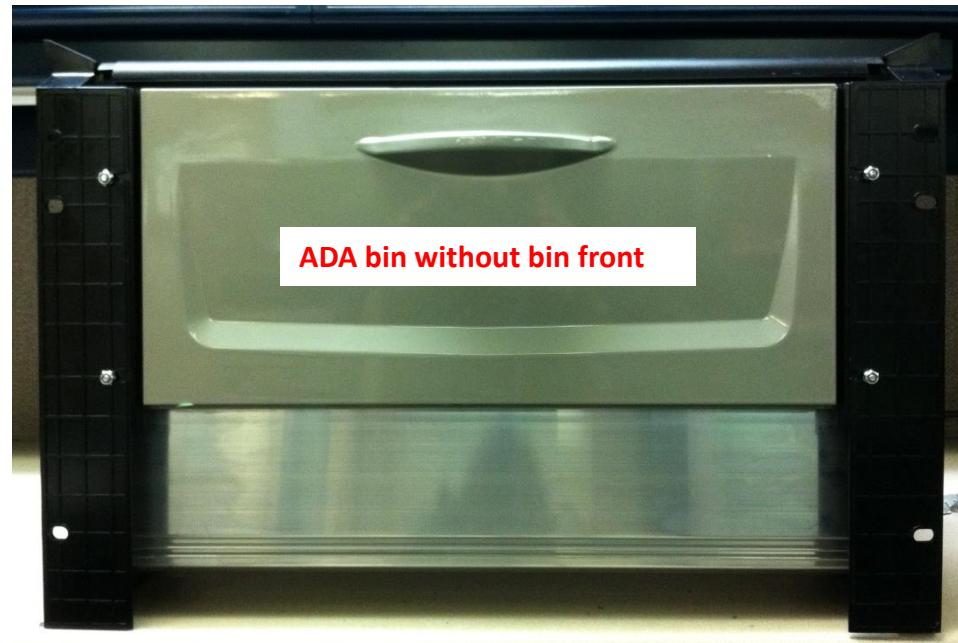
## Bin/bin Front Assembly

Slide bin off cabinet hinges and remove from cabinet (would be best to sit on table). Unfasten the 7/16" nuts (6x) from the back of the bin assembly then remove the bin panel and place to the side.

With the bin front removed, test the bin to see if the door still jams. If it does not, this means there is some type of interference between the bin front and the bin.

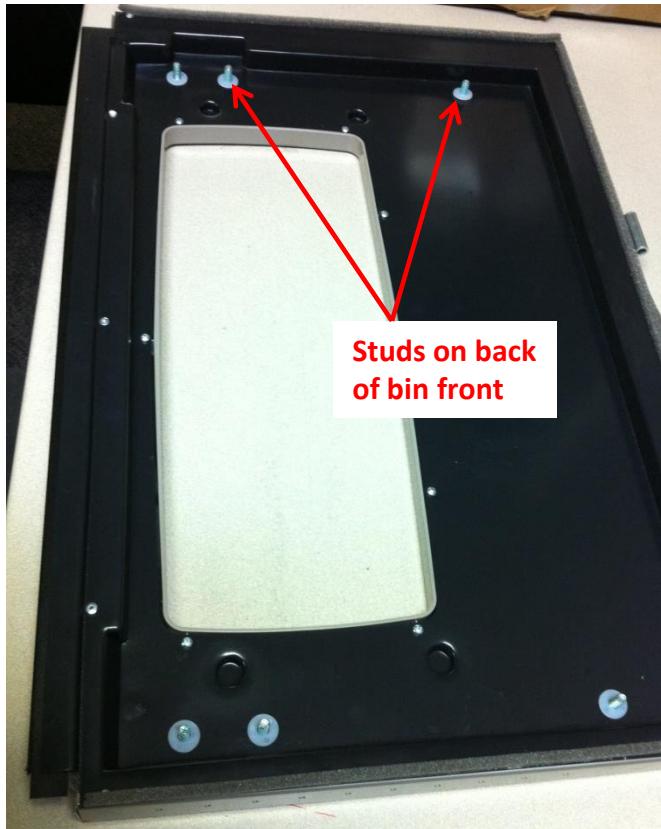
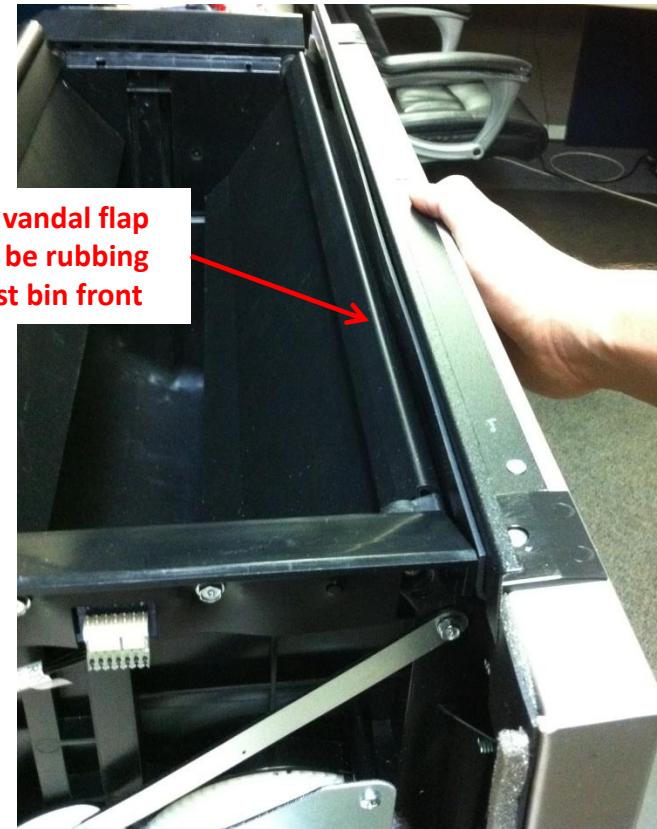
## Bin/bin Front Assembly (continued)

Inspect the back of the bin front to see if there is a loose rivet, piece of foam, debris etc. that is interfering with the bin. If so, remove the interference. If this is the case, place bin front back on bin and retest door to see if it still jams.

If there is no visible interference, try adding washers to each of the 6 studs to move the bin front away from the bin. Start by placing 1 on each stud, reinstall on bin, tighten down the nuts and test the door. If the door still jams try adding 2 washers to each stud. Don't go over a total washer thickness of .100". FYI, two dimes stacked on top of each other equals .100"

When reinstalling the bin front, try to do so with the bin on edge of a table and the bin front hanging off the edge of the table for easiest use.

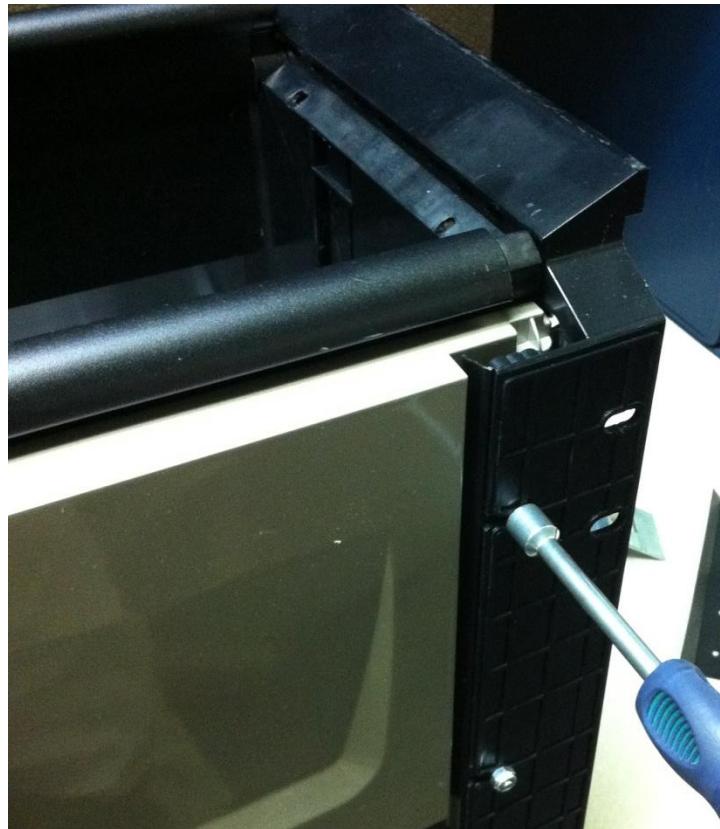
## Bin Door Length Adjustment

Try loosening the 11/32" nuts (2x) located on each door slide. This should allow the sidewalls to properly adjust if the length of the door is too small compared to the extrusions.

After loosening nuts, test the door. If it works without getting jammed, retighten the nuts at the adjusted length and test door again. If the door does not work when nuts are tightened, leave nuts loose and reinstall bin front to test door.

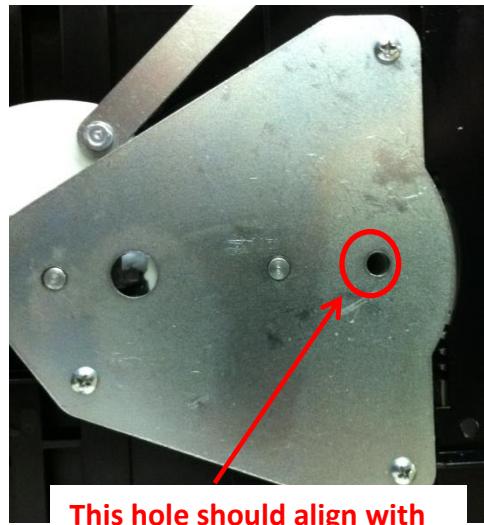
This hole should align with pilot hole on mating gear/gear rack

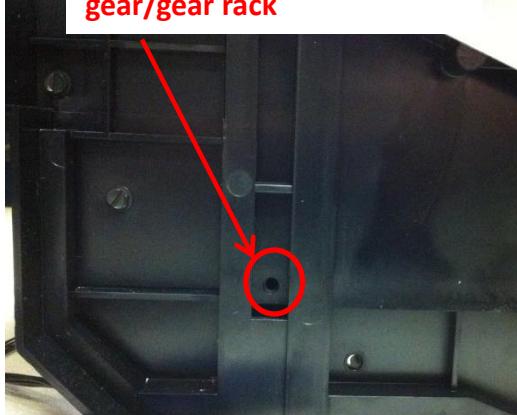
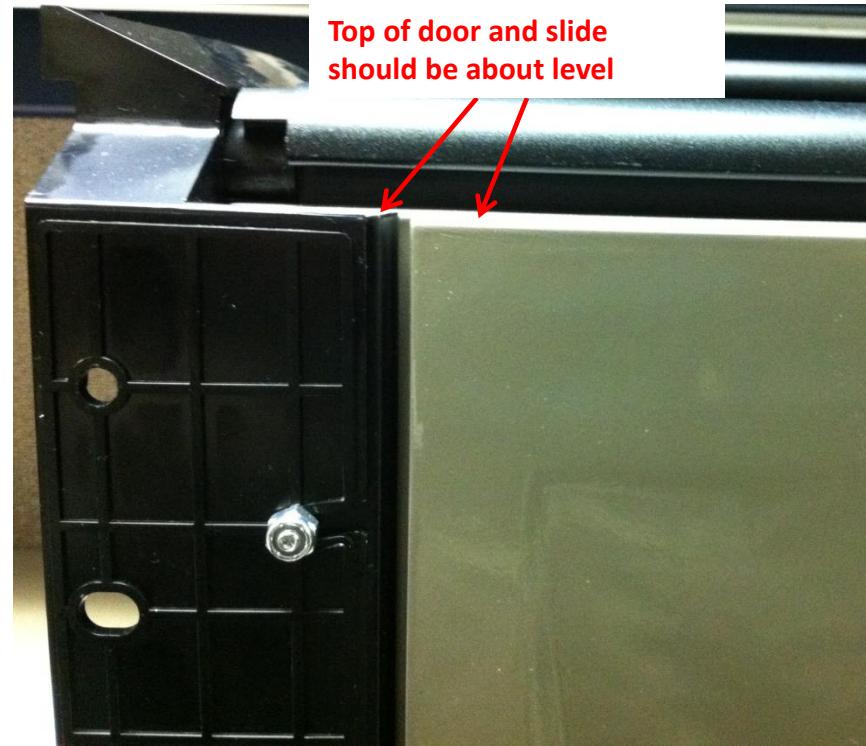
# Gear Alignment

Top of door and slide should be about level

Check to see if the bucket gear racks, the door gear rack and the gears located on the sides of the bins are all properly aligned. The checks include:

1. Top of the bin door is about level with the slides
2. Hole on the primary gear is aligned with hole on the gear plate
3. Hole on the bottom of each side wall is aligned with hole on each gear rack mounted to either side of the bucket

If either of these checks is not correct, refer to gear alignment procedure to address

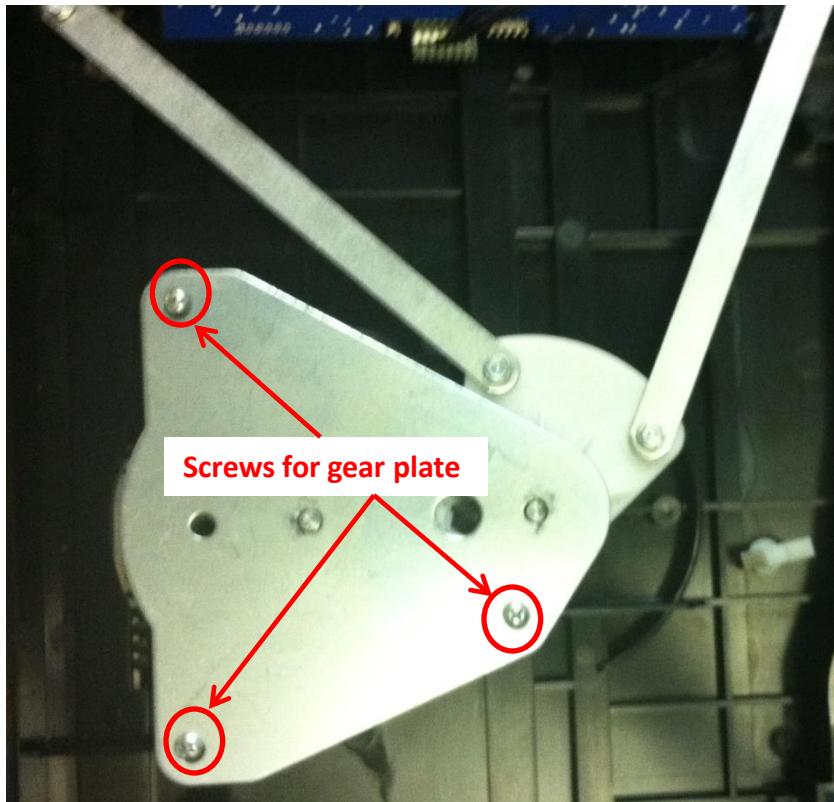
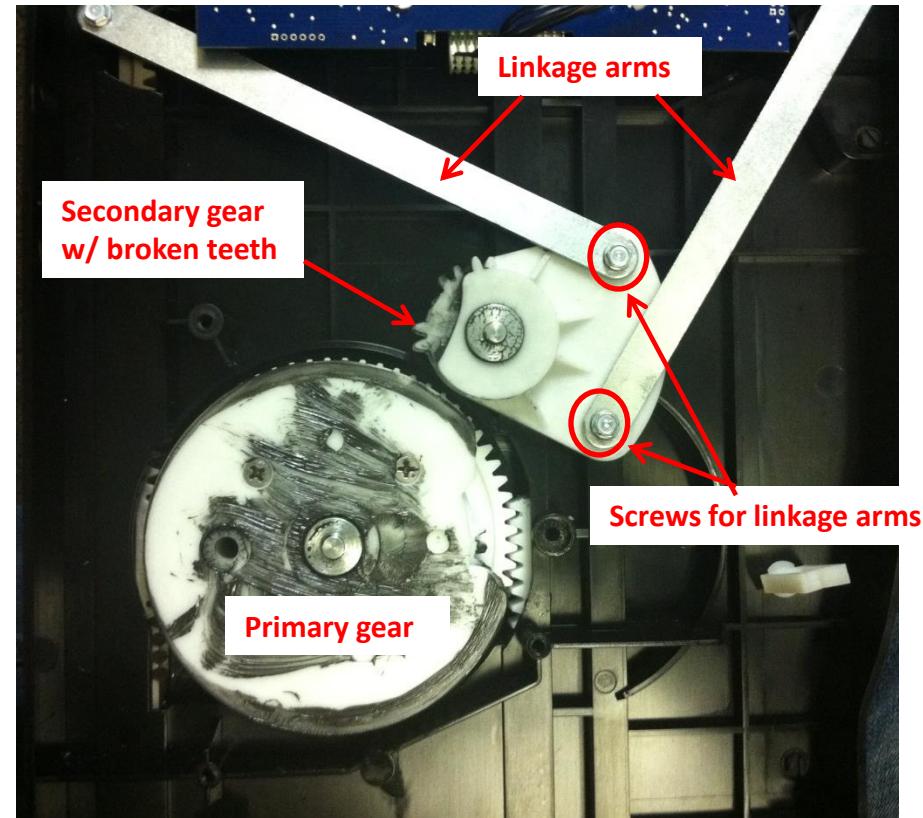
# Broken Gear Teeth

The secondary gear that controls the vandal flaps may have broken teeth due to a product jam. To check the teeth on the secondary gear, remove the gear plate by unfastening the 3 Phillips head screws and place gear plate to the side. Try to avoid touching any of the grease. Observe the teeth of the secondary gear. If there are any broken teeth, lift the gear out of its seat and remove from linkage arms using a  $\frac{1}{4}$ " socket. You will have to replace this component for bin to function. The part numbers for the secondary gear are CR0013463 (right) and CR001544 (left).

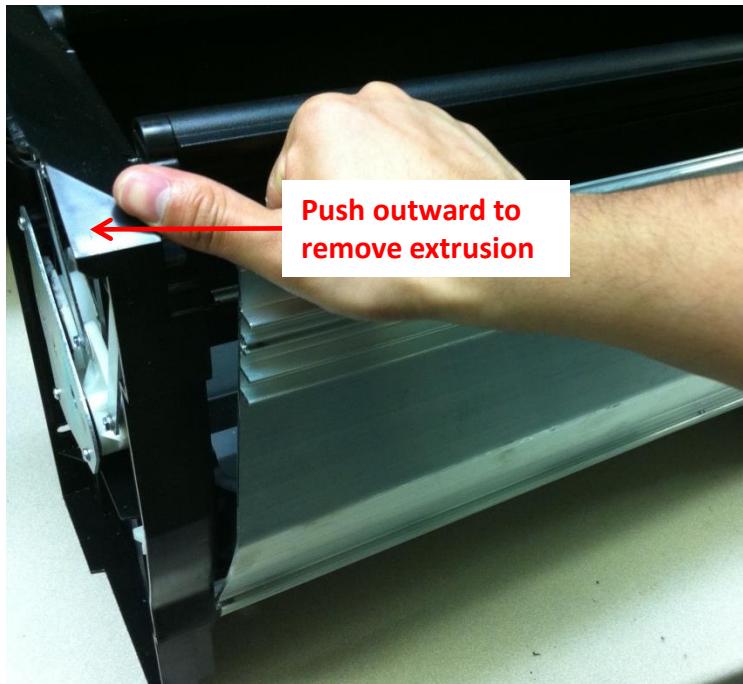
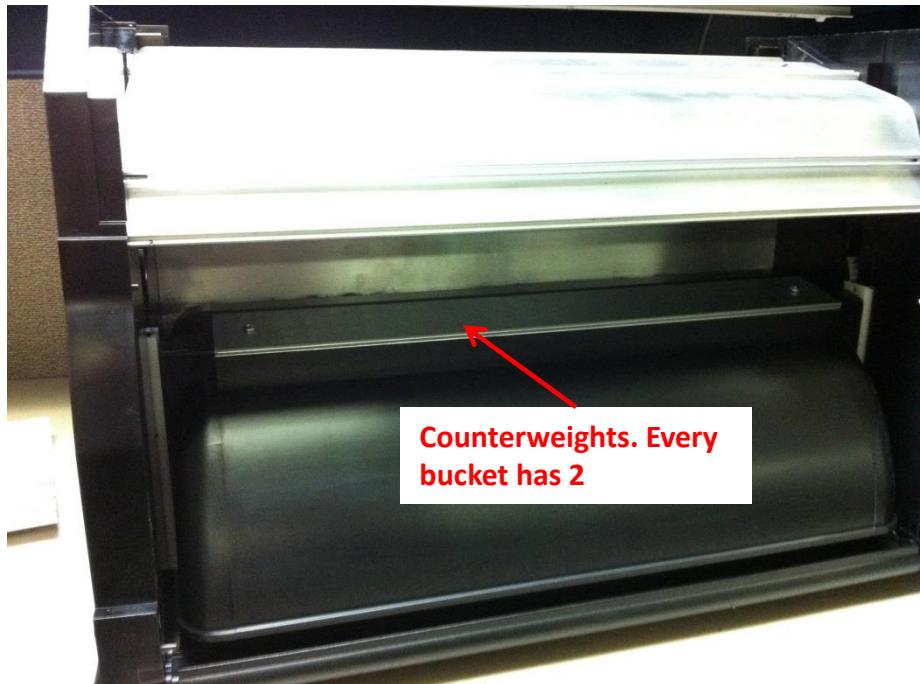
## Bucket Counter Weights (rear extrusion)

The mounting screws for the counter weights located under the bucket may have stripped out. Without these weights, there is nothing to bring the door up to close position. In order to look beneath the bucket, one of the extrusions will have to be removed. To remove the rear extrusion, unfasten all 4 of the  $\frac{1}{4}$ " hex head screws mounting the extrusion to the sidewalls and remove from bin assembly.

Once it is removed, flip the bin upside down and inspect the bottom of the delivery bucket. There should be 2 weights mounted to the bottom. If weights have fallen off due to screws stripping, reattach ensuring the screws are #7 x  $\frac{1}{2}$  plastite screws (PN 6922104). Note if the screws that stripped out are smaller than a #7.

If removing the rear extrusion, the best tool to use to fasten down the weight is a 90 degree drill or a Phillips socket with wrench.

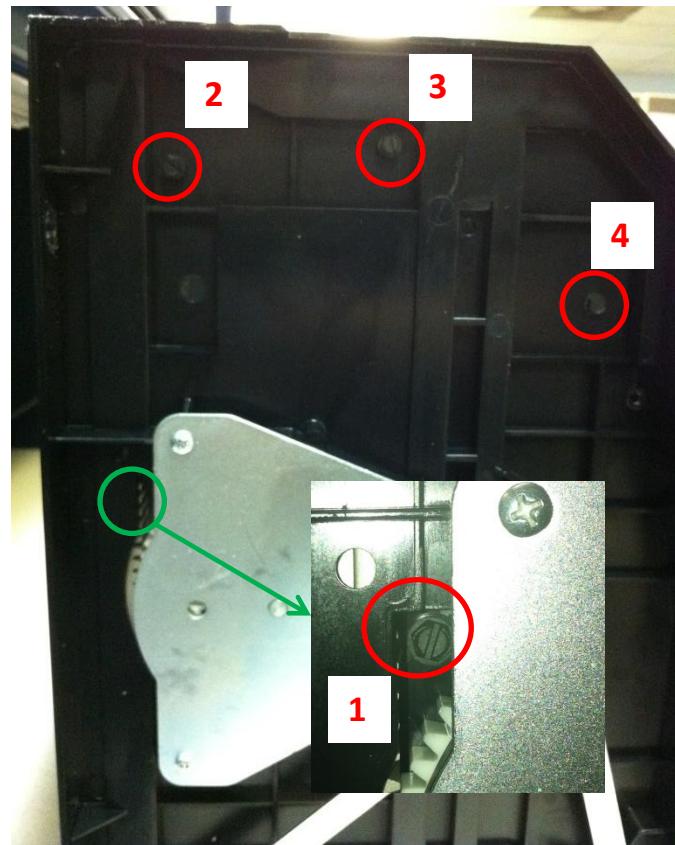
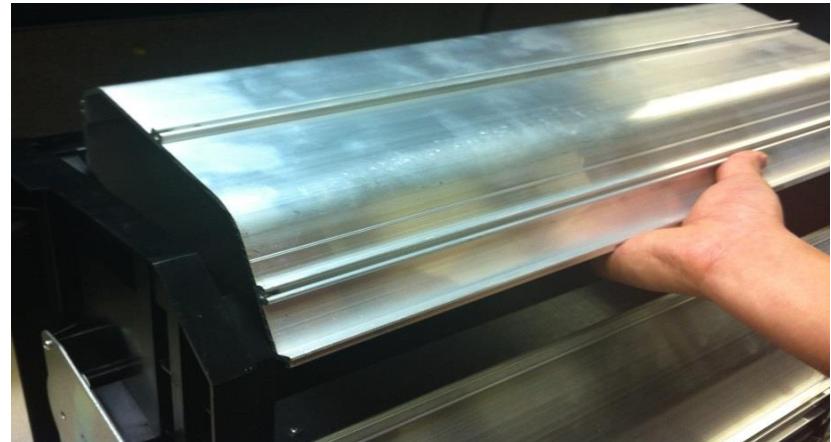
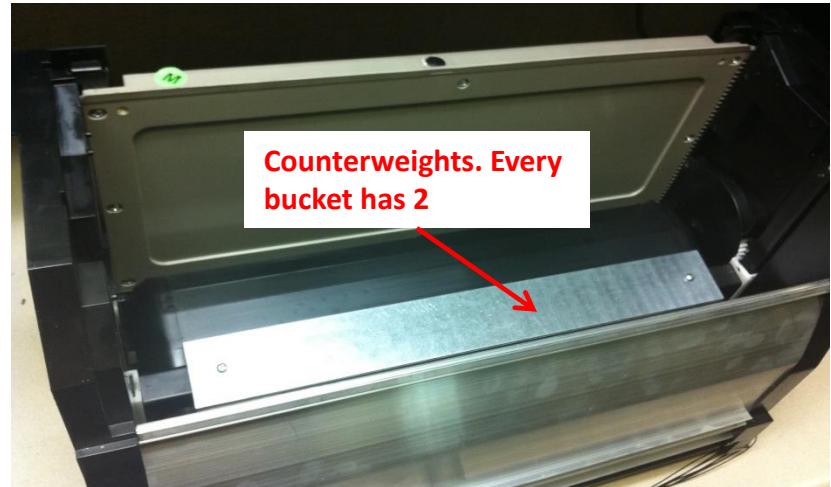
## Bucket Counter Weights (front extrusion)

The other way to look under the bucket is to remove the front extrusion. To do this, turn the delivery bin upside down and remove all 8 of the  $\frac{1}{4}$ " hex head screws mounting the extrusion to the sidewalls. The first screw will be difficult to get to because of its location; it would be best to use a nut driver to get to this one.

Once all fasteners are removed, lift extrusion out and look under the bucket for the counterweights. If they have fallen off due to screw stripping out, reattach, ensuring the screws are #7 x  $\frac{1}{2}$  plastite screws (PN 6922104). Note if the screws that stripped out are smaller than a #7.
